## EFFECT OF *CONOCARPUS ERECTUS* ON THE INFRASTRUCTURE OF MISAN PROVINCE, IRAQ

*C. erectus* is a fast-growing and drought-resistant tree, for these reasons it is widely planted in the southern part of Iraq around parking and along the streets in recent years. The ministry of municipalities and ministry of higher education of Iraq has banned this species based on rumors about the infrastructure damages caused by this tree. So the purpose of this study is to investigate the reality of these damage to infrastructure on the basis of scientific principles. This study lasted for two years in cooperation with services directorates (municipal, sewage, water, and communications) in Misan province. Four infrastructure damages caused by this tree have been reported three out four were reported in drinking water pipes led to water outages for few days, and the other one was reported in the domestic sewage causing a blockage at the junction of sewer pipes. Any case of damage to streets, sidewalks and line services (electricity and internet) were not reported in the present study. According to soil tests and other parameters including (tree height, length of the root, the pruning and the dista

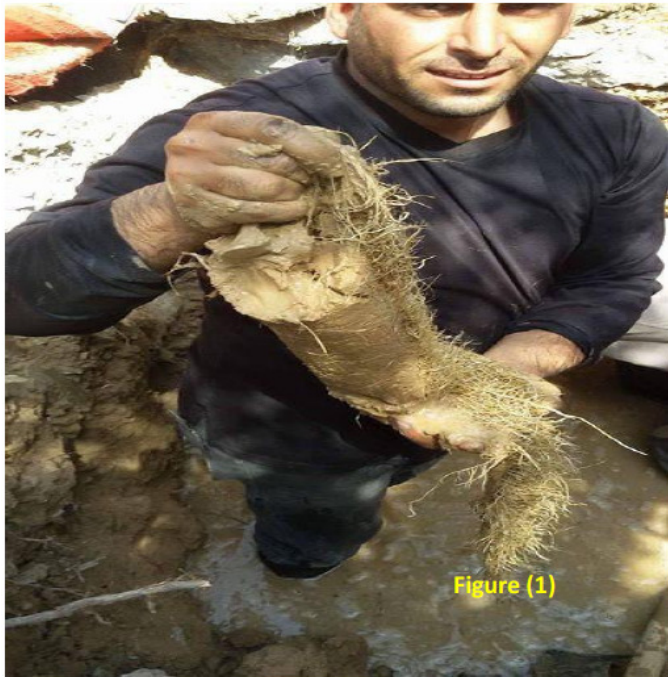
Figure (1)

Fig. 1 : shows The roots are pierced in the water pipe in Al-Ressala Sector

According to the recorded data, the results of the current study showed that four cases of damage caused by *C. erectus* to the infrastructure, three cases of them were reported in drinking water pipes in residential areas (Al-Ressala, Al-Wahda, and Al-Shobana) led to water outages in residential areas for few days (Fig. 1, 2, 3), and one was reported in the domestic sewage (in Alsadekh sector) causing a blockage at the junction of sewer pipes (Fig. 4). Any case of damage to streets, sidewalks and line services (electricity and internet) were not reported in the present study.

The study showed the main reasons why the roots of the *C. erectus* have been damaged in infrastructure .here, we have to suggest some solutions to get rid of the damage, because the tree bears the environment and gives beautiful green growth. 1- Regular irrigation.so that the root does not extend too deep and cause damage to infrastructure. 2- Pruning leaf to reduce water loss. 3 - plant trees away from the infrastructure, This tree can be used as a windbreaker around the cities, or forest being the tree talking of lack of water and own a powerful root and growth of its vegetative all dense.
